INVENTORY OF MONUMENTS AT PAGAN

Volume One
Monuments 1-255

PIERRE PICHARD

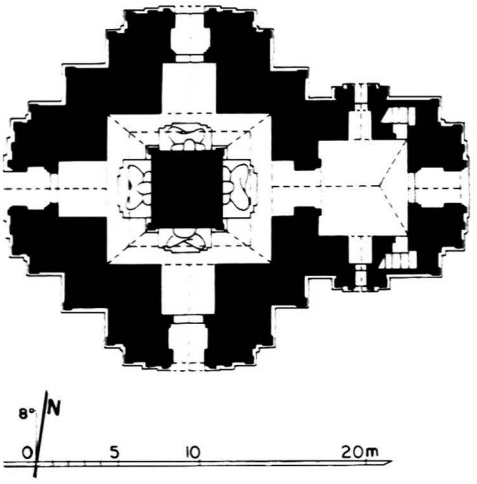
844 a - Plan

5 present condition
- regularly maintained.
- upper part of square tower destroyed.

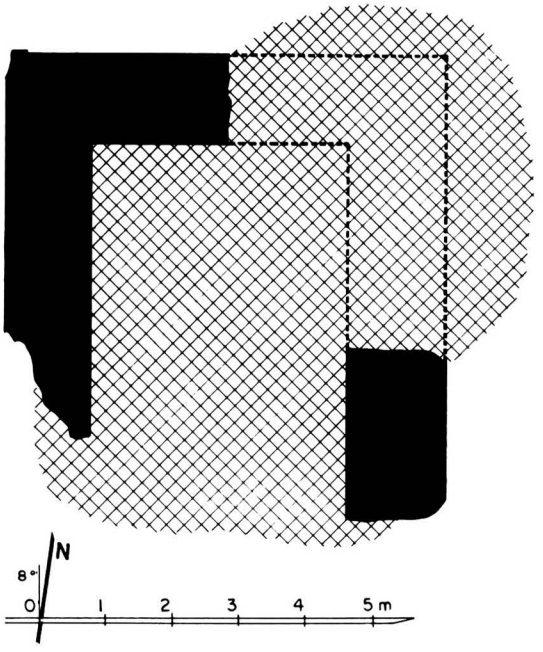
846 a - Plan

5 present condition
- ruined.
- no more trace of vaults.
- ground floor buried under debris.

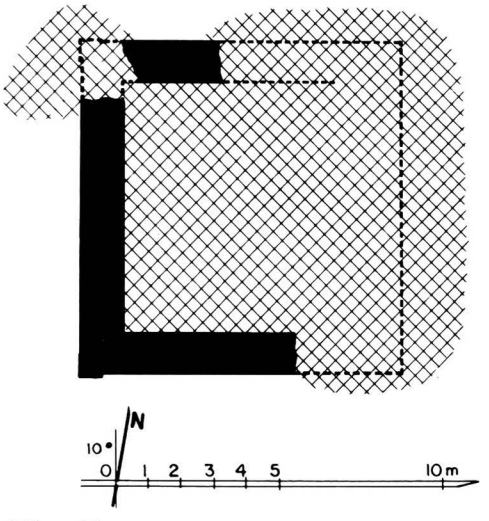
848 a - Plan

5 present condition
- ruined.
- no more trace of vaults.
- ground floor buried under debris.

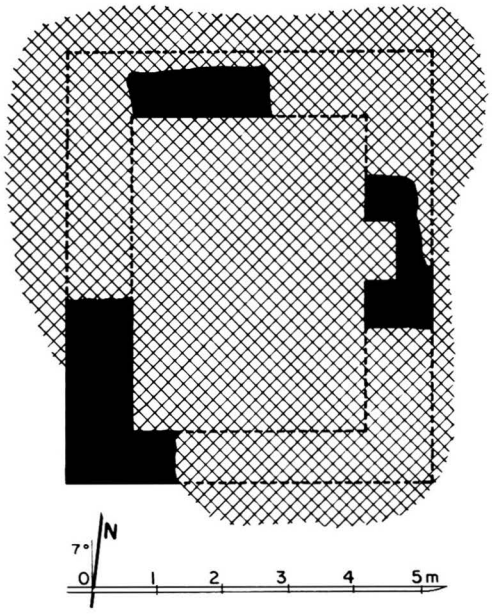
849 a - Plan

5 present condition
- ruined.
- no more trace of vaults.
- ground floor buried under debris.

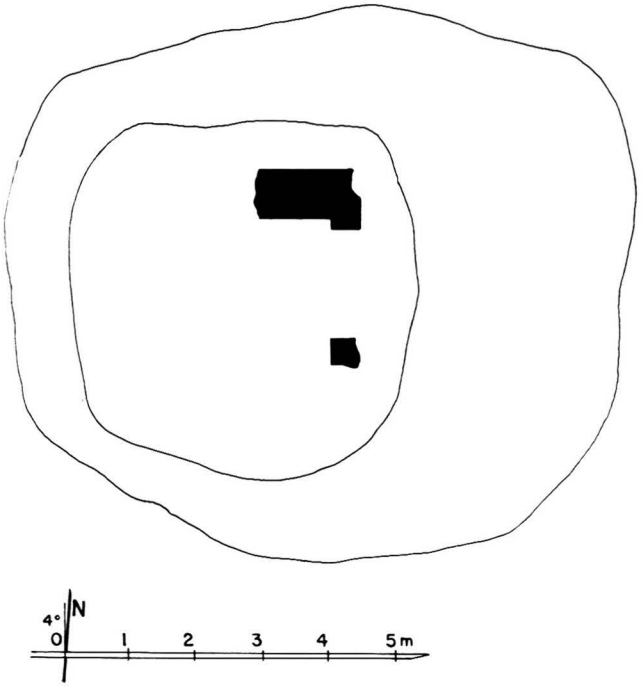
851 a - Plan

5 present condition
- only parts of east wall remaining.
- height: approx. 2.60 m.

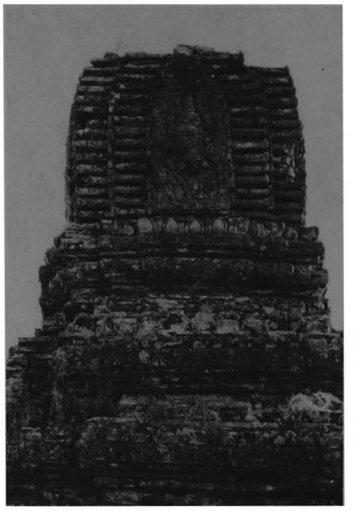
852 c - South face

5 present condition
- half-ruined and endangered.
- upper parts badly damaged.

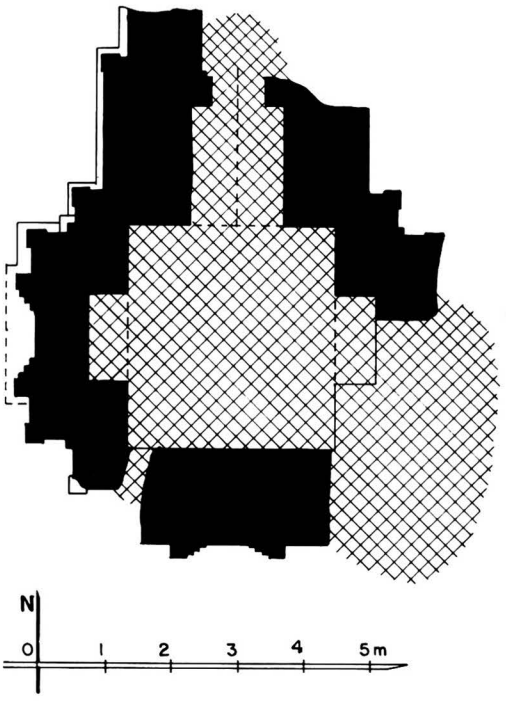
854 a - Plan

5 present condition
- ruined.
- vaults and upper parts collapsed.
- structure badly cracked.
- ground floor buried under debris.

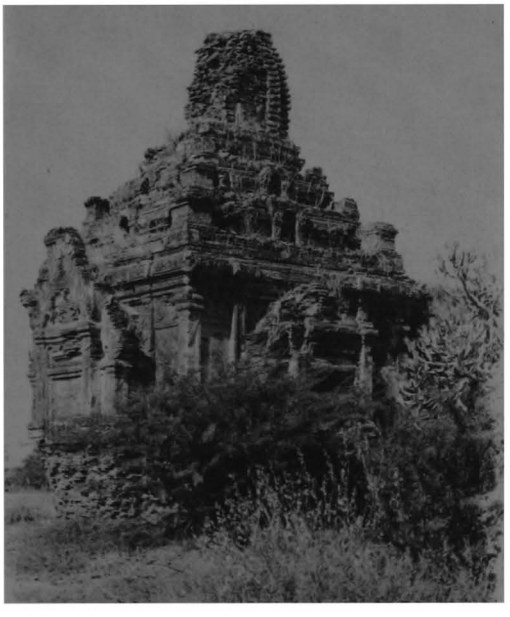
856 b - From south-east

5 present condition
- no maintenance.
- base disintegrated.
- upper parts badly damaged.

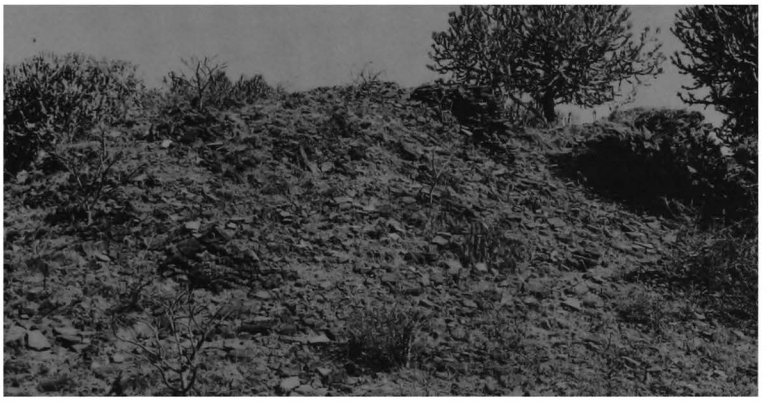
859 b - From south-west

5 present condition
- brick debris.
- height: approx. 2.80 m.

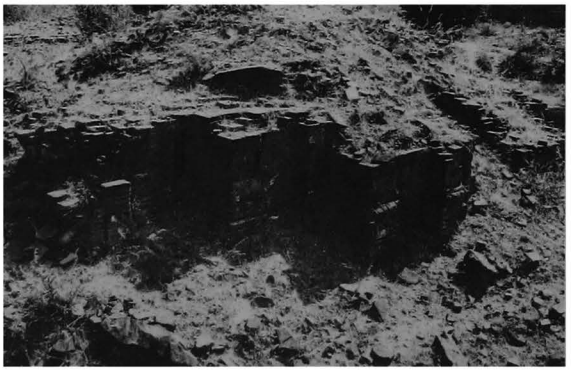
860 c - From north-west

5 present condition
- ruined.
- vaults and upper parts collapsed.
- ground floor buried under debris.

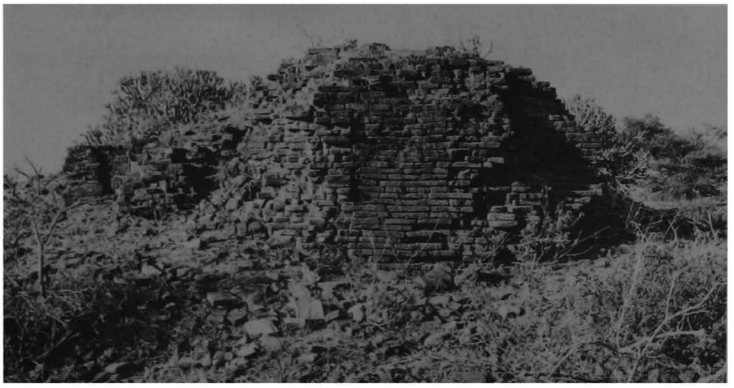
864 c - South face

5 present condition
- ruined.
- vaults and upper parts collapsed.
- ground floor buried under debris.

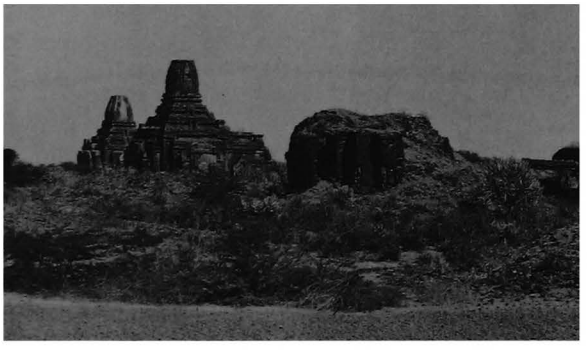
867 c - From south-west

5 present condition
- ruined.
- vaults and upper parts collapsed.
- structure badly cracked.
- ground floor buried under debris.

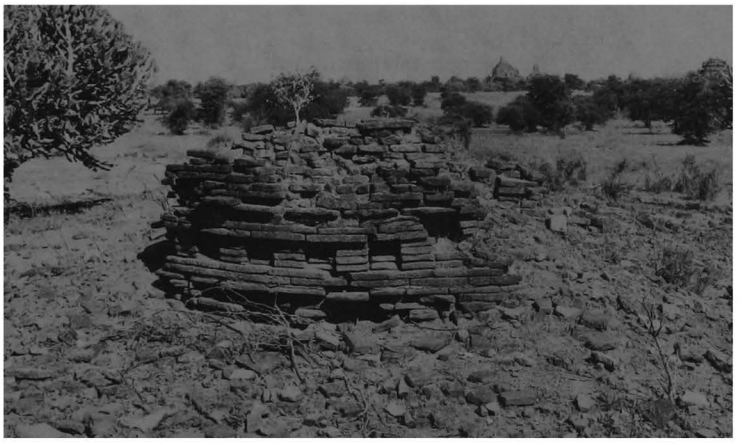
5 present condition
- ruined, height: 1.40 m.
- terraces disintegrated.
- upper parts collapsed.

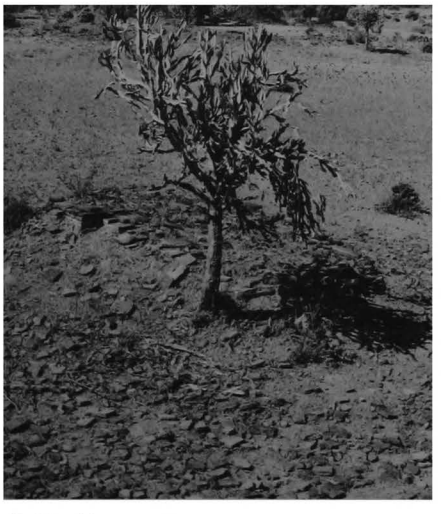
5 present condition
- ruined, height: 1.60 m.
- vaults and upper parts collapsed.
- ground floor and base buried under debris.

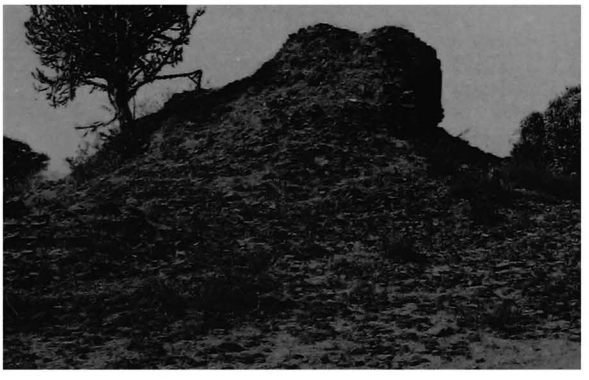
5 present condition
- ruined.
- vaults and upper parts collapsed.
- ground floor buried under debris.

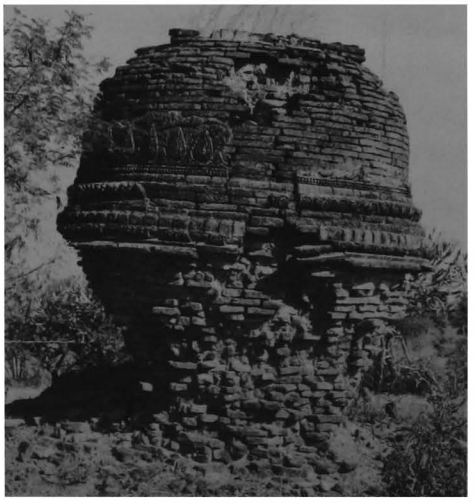
880 c - From south

5 present condition
- half-ruined and endangered.
- base and terraces disintegrated.

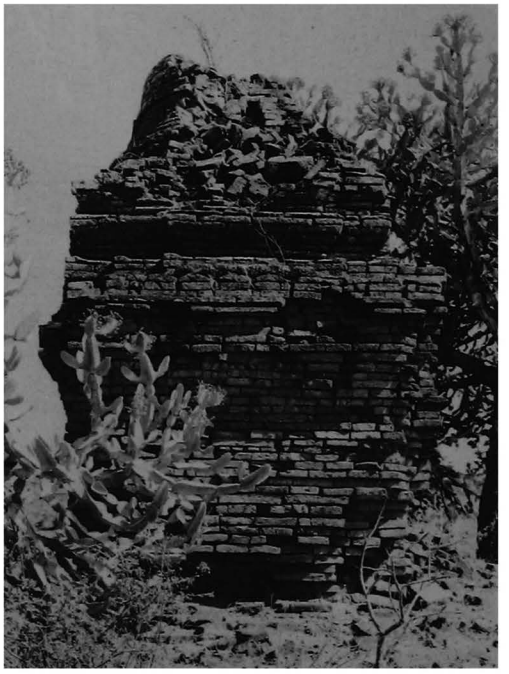
886 c - West face

5 present condition
- half-ruined.
- base and terraces disintegrated.
- upper parts nearly destroyed.
- leaning eastward.

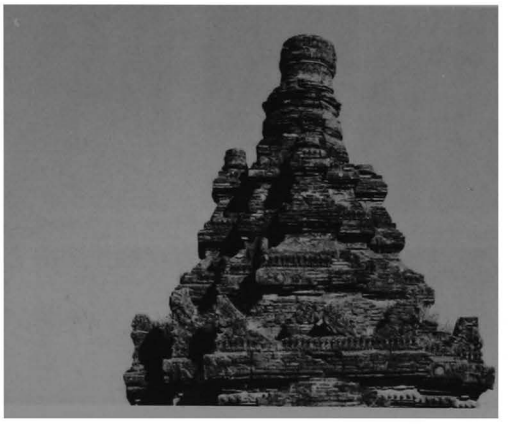
889 b - Upper parts, south face

5 present condition
- repaired 1964.
- brick grilles built by Arch. Dept.

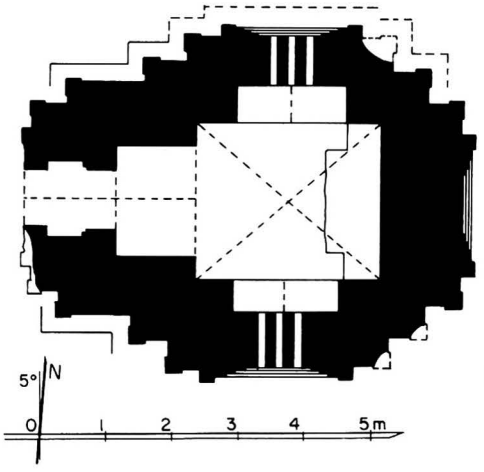
892 a - Plan

5 present condition
- half-ruined.
- base disintegrated.
- east porch collapsed.
- upper parts badly damaged.

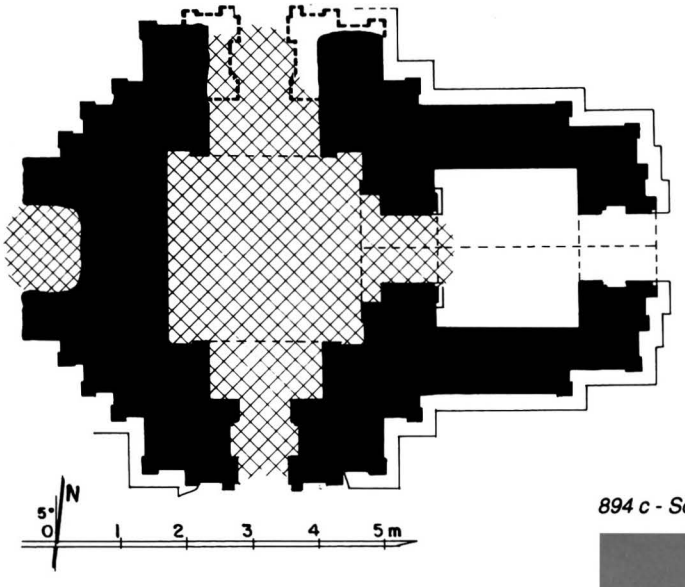
894 a - Plan

5 present condition
- ruined.
- vaults, upper parts and square tower collapsed under the 1975 earthquake.
- ground floor buried under debris.

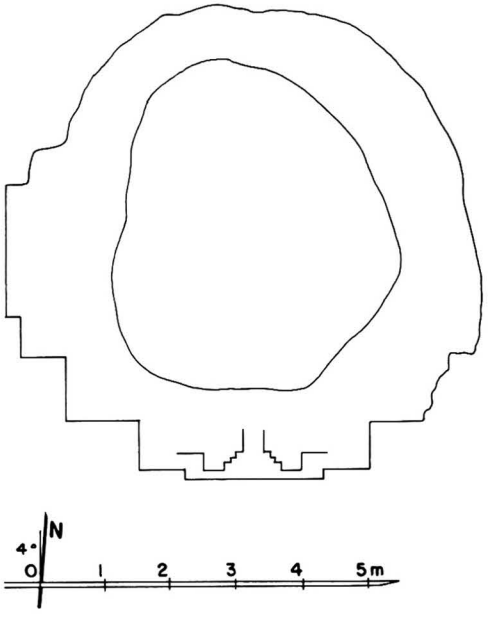
895 a - Plan

5 present condition
- ruined.
- only base of walls remains.
- ground floor buried under debris.

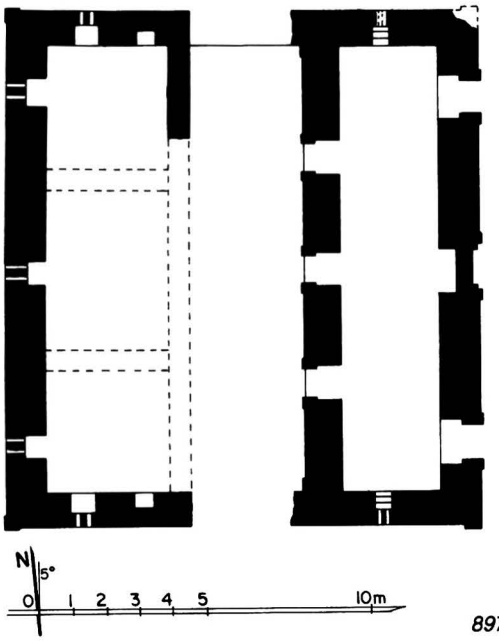
897 a - Plan

5 present condition
- ruined.
- no trace of vaults.
- vaults collapsed.
- west wall, vaults and roof collapsed.

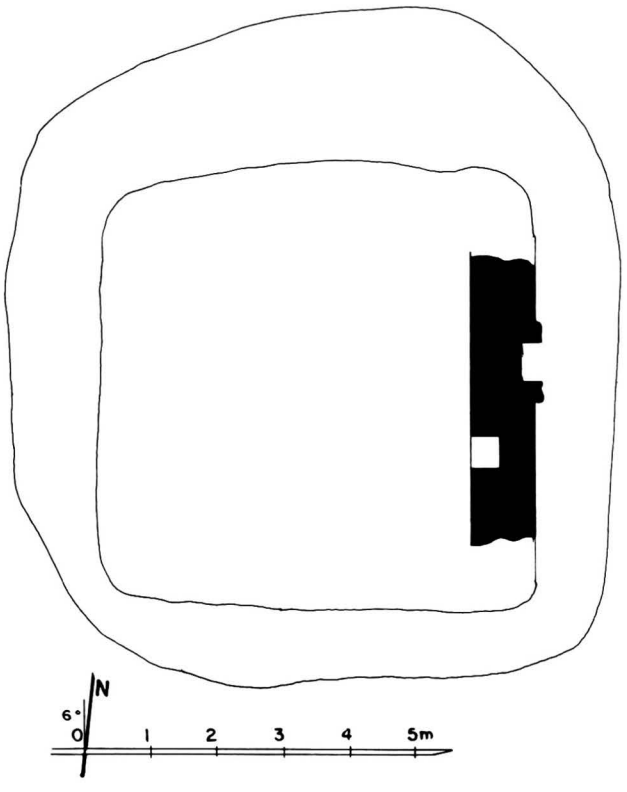
898 a - Plan

5 present condition
- ruined.
- only part of east wall remains.
- ground floor buried under debris.

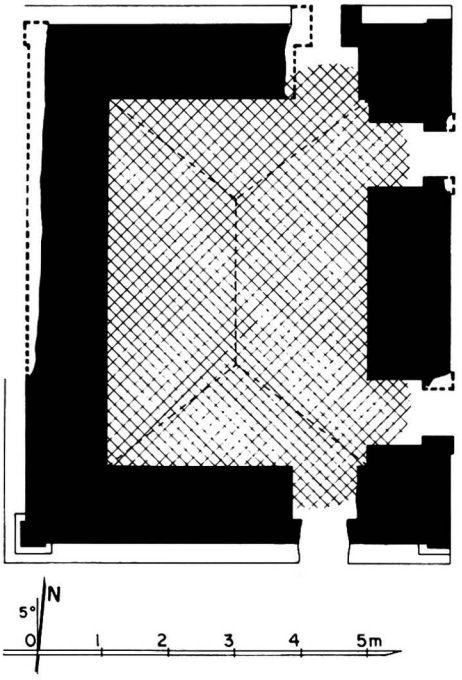
899 a - Plan

5 present condition
- ruined.
- vaults collapsed.
- ground floor buried under debris.

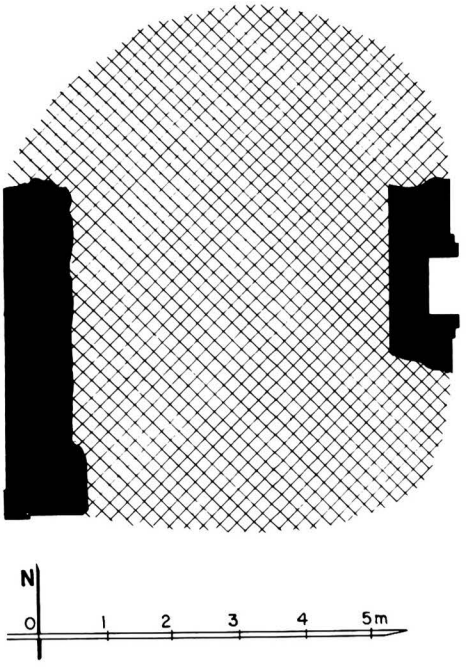
900 a - Plan

5 present condition
- ruined.
- no more trace of vaults.
- ground floor buried under debris.

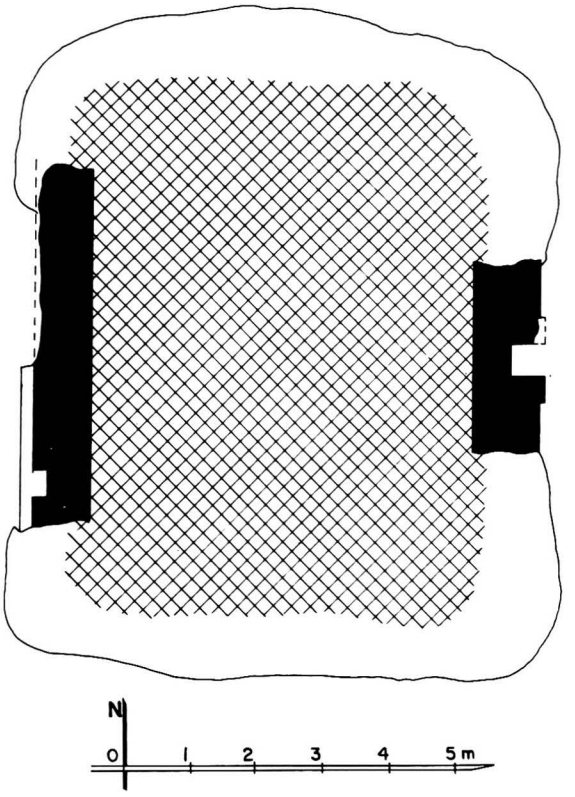
901 a - Plan

5 present condition
- ruined.
- walls and vault collapsed.
- ground floor buried under debris.

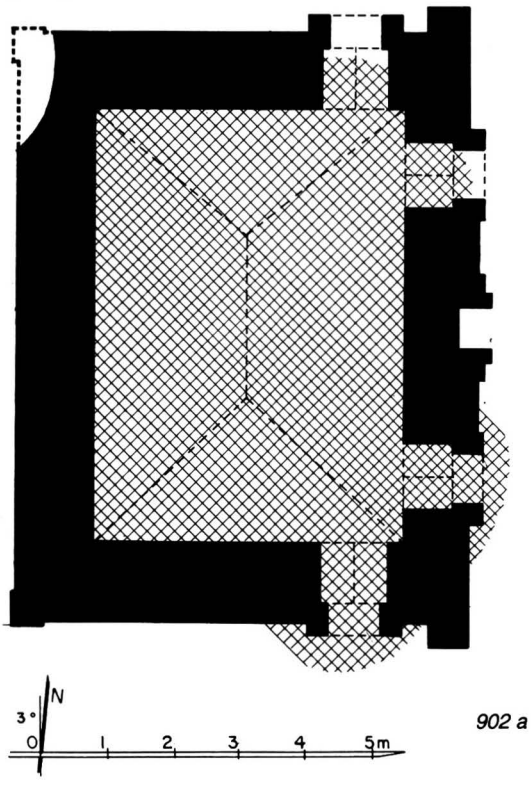
902 a - Plan

5 present condition
- ruined.
- vault collapsed.
- ground floor buried under debris.

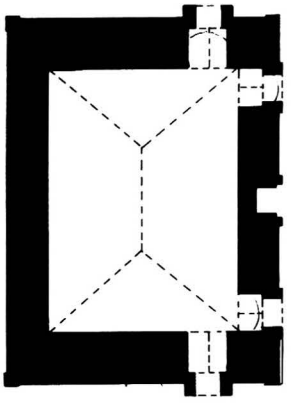
903 a - Plan

5 present condition
- ruined.
- no more trace of vaults.
- ground floor buried under debris.

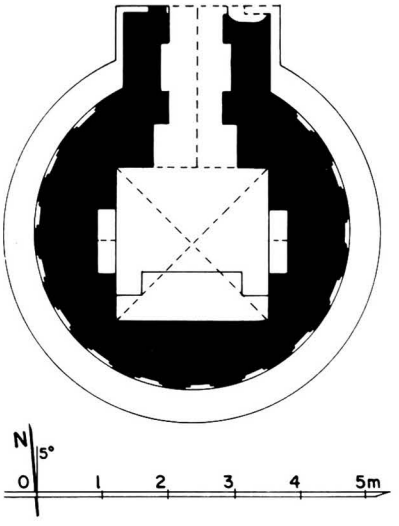
904 a - Plan

5 present condition
- no maintenance.
- north porch collapsed.
- upper parts badly damaged.

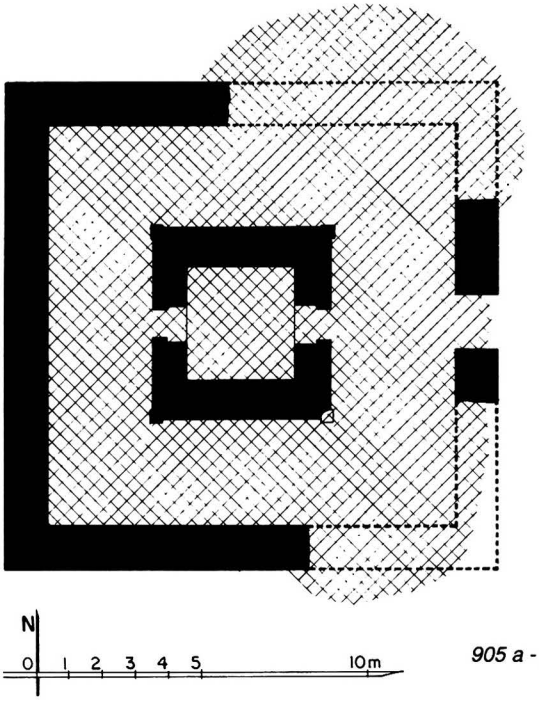
905 a - Plan

5 present condition
- ruined.
- no more trace of vaults.
- ground floor buried under debris.

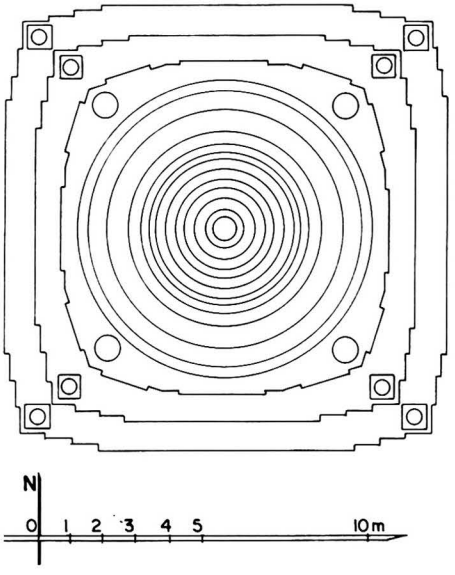
906 a - Plan

5 present condition
- maintained by monastery.
- whitewashed.
- upper parts leaning northwards.

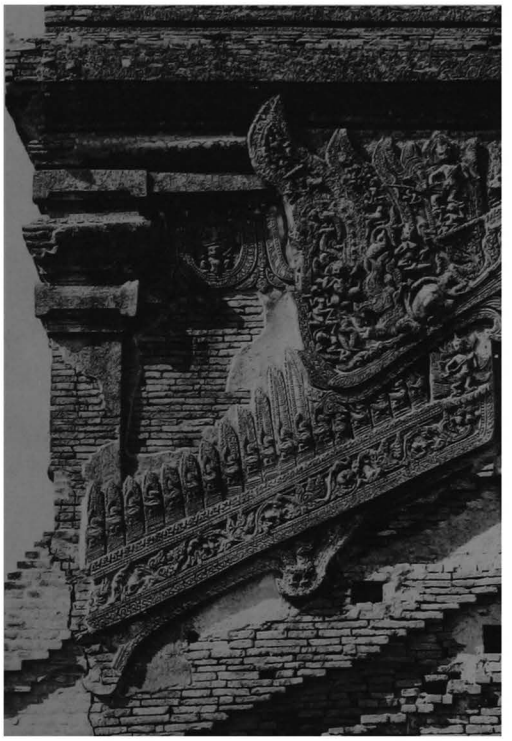
907 c - East face, 1986

5 present condition
- walls and vaults partly collapsed.
- repaired 1965.
- north-west corner collapsed 1990.
- repaired and strengthened (Const. Corp.) 1992-93.

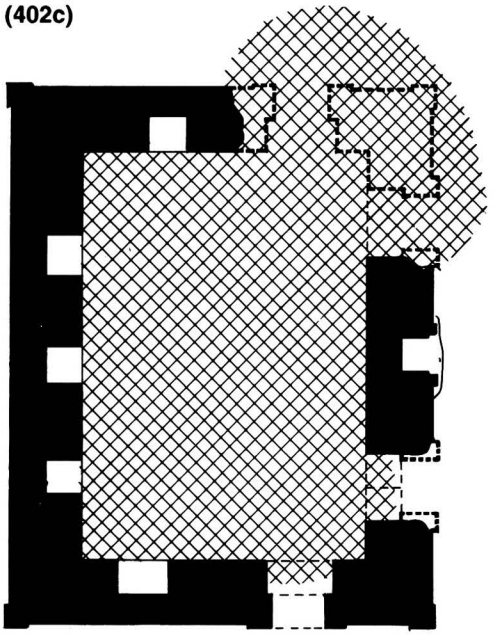
910 a - Plan

5 present condition
- ruined.
- vault collapsed.
- ground floor buried under debris.

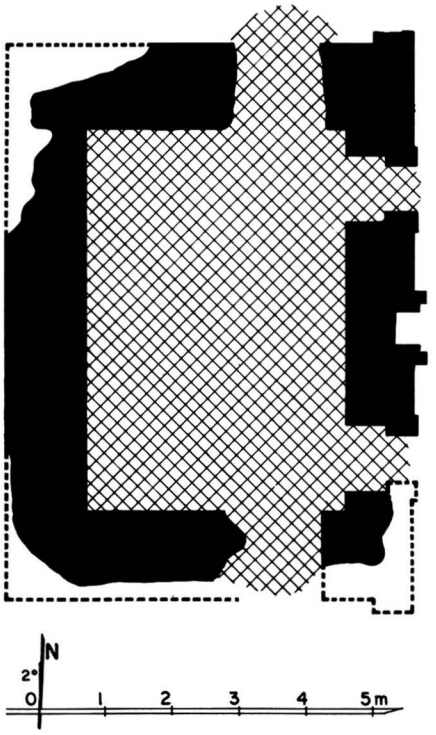
911 a - Plan

5 present condition
- ruined.
- vault collapsed.
- ground floor buried under debris.

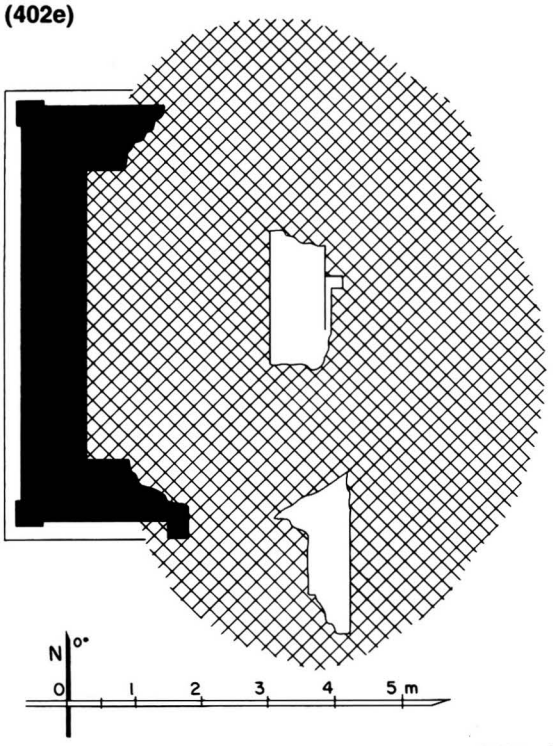
912 a - Plan

5 present condition
- ruined.
- vault collapsed.
- only west wall remains.
- ground floor buried under debris.

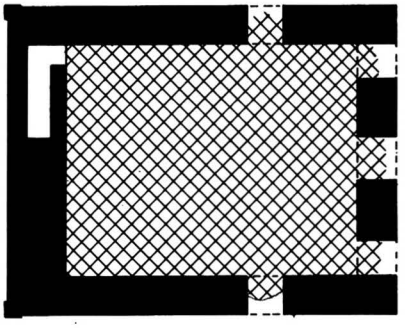
916 a - Plan

5 present condition
- ruined.
- walls and vault collapsed.
- ground floor buried under debris.

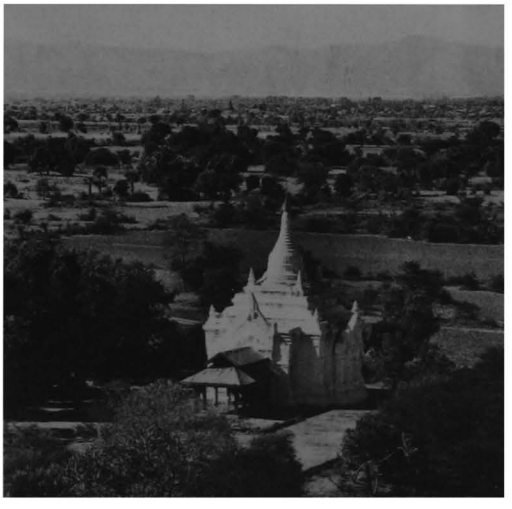
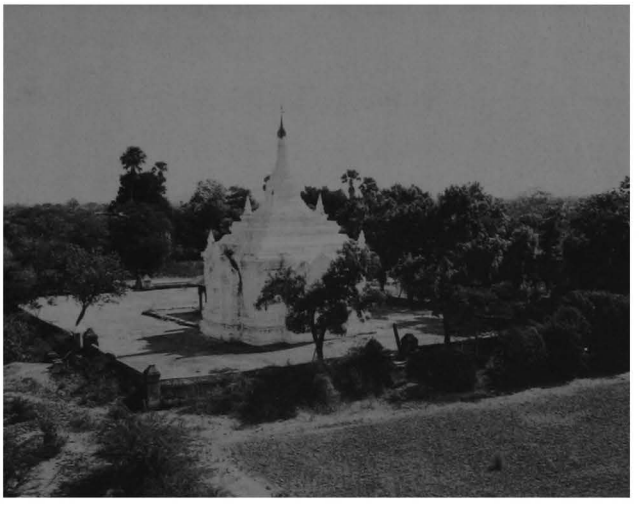
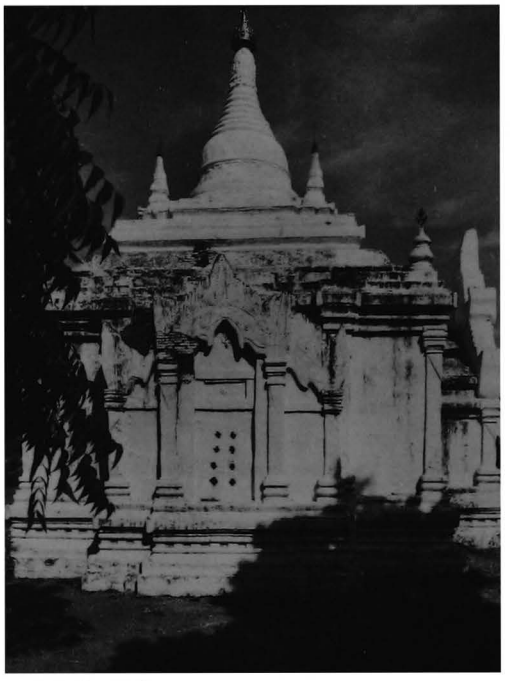
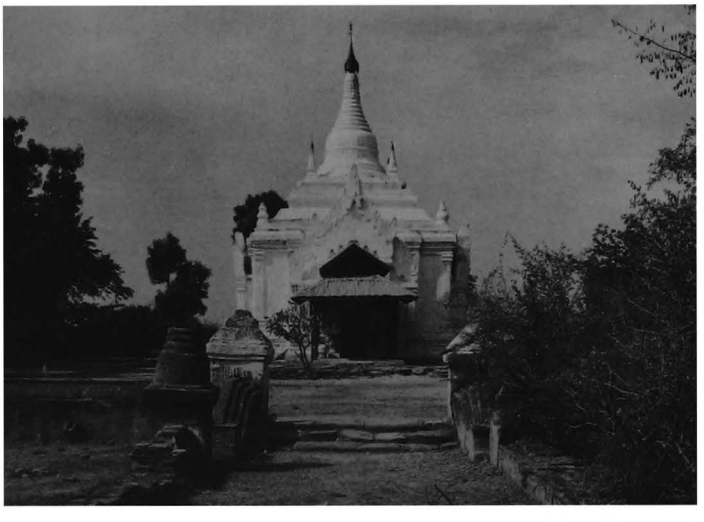
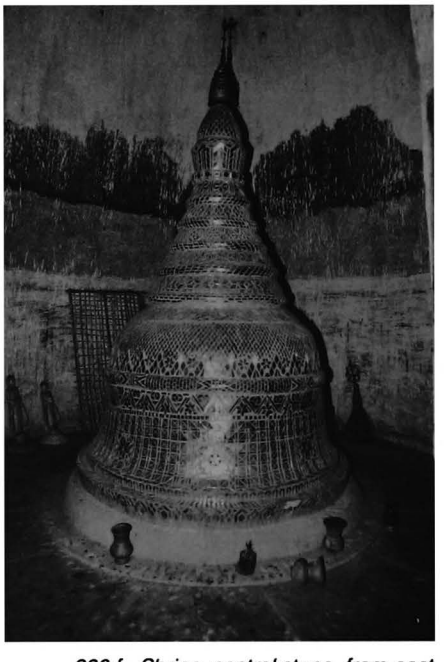
5 present condition
- maintained by monastery.
- whitewashed.
- upper parts renovated.

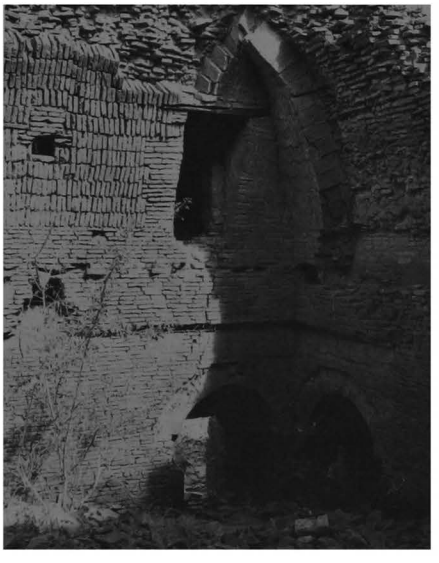
921 e - Central room, north-east corner, from south-west

5 present condition
- half-ruined.
- vault collapsed.
- ground floor buried under debris.

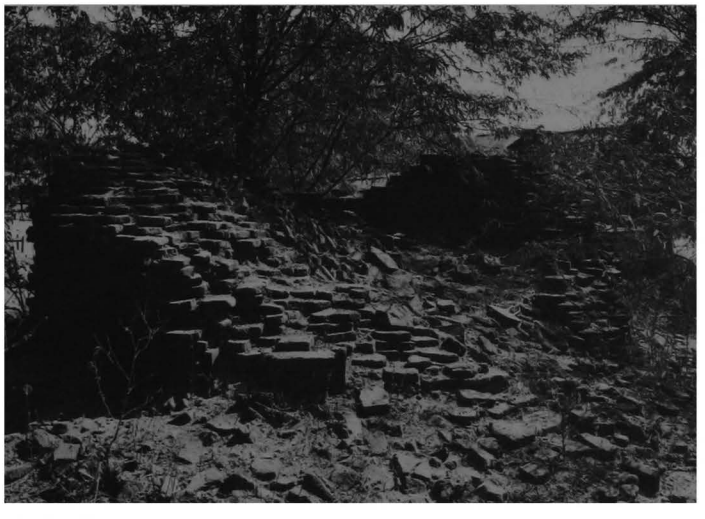
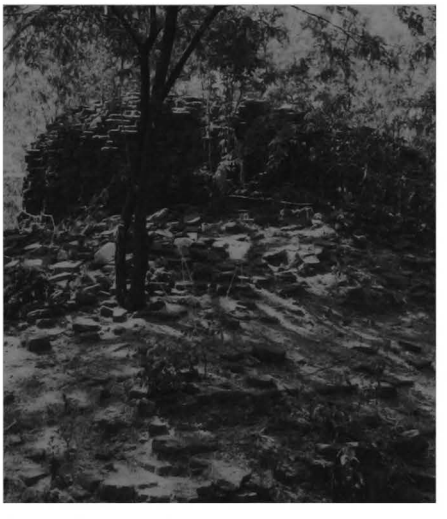
5 present condition
- ruined.
- present height: 3.10 m.

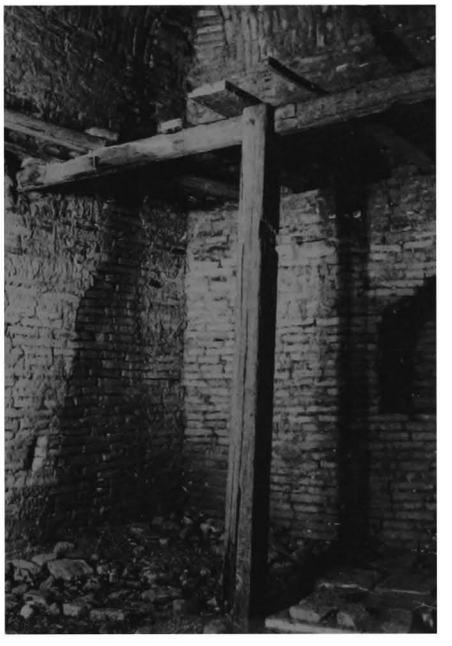
925 d - Central room, south-west corner, from S.E.

5 present condition
- half-ruined.
- outer wall and vault over corridor collapsed.

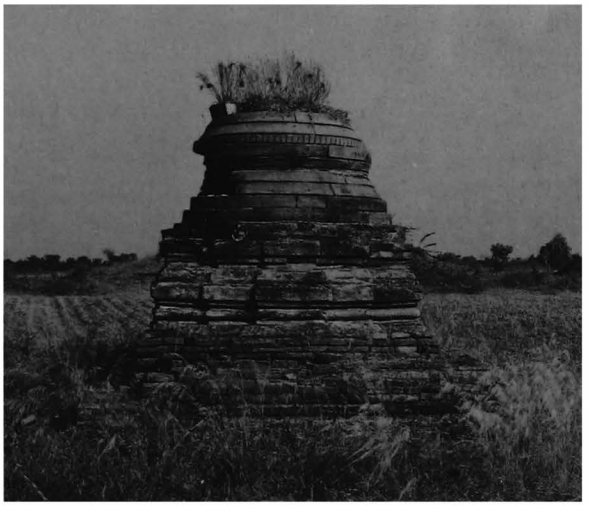
928 b - From north-east

5 present condition
- half-ruined.
- upper parts damaged.

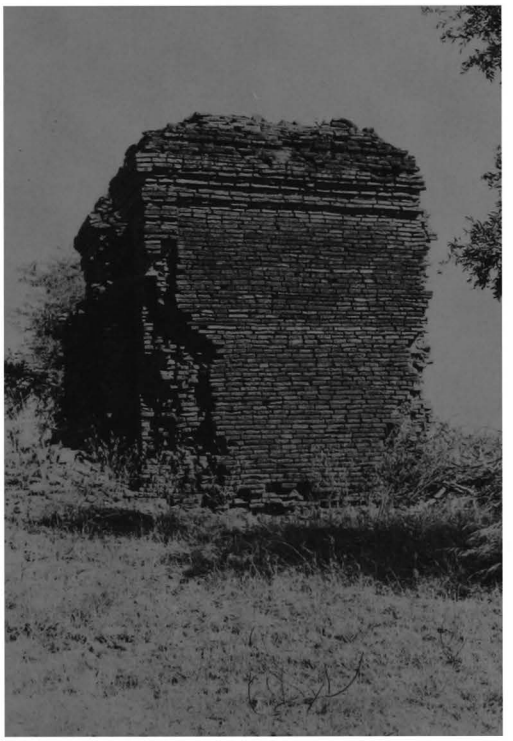
5 present condition
- ruined.
- vaults and upper parts collapsed.
- structure badly cracked.
- ground floor buried under debris.

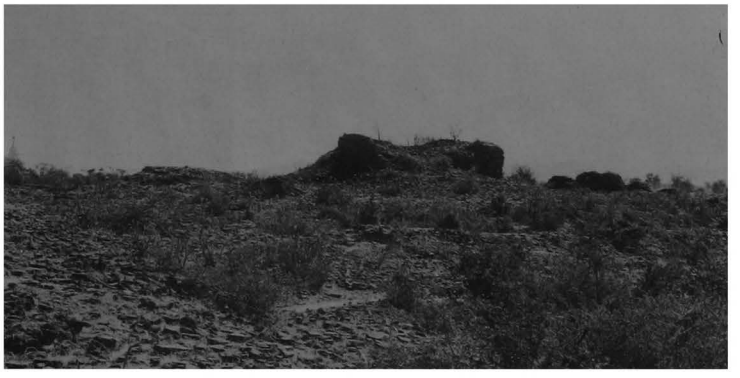
940 b - From north-west

5 present condition
- ruined.
- walls and vault collapsed.
- ground floor buried under debris.

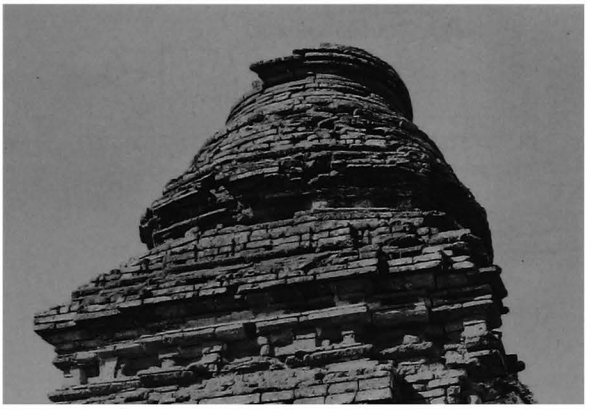
943 b - Upper parts, from north-east

5 present condition
- no maintenance.
- upper parts damaged.
- base cracked and partly disintegrated.

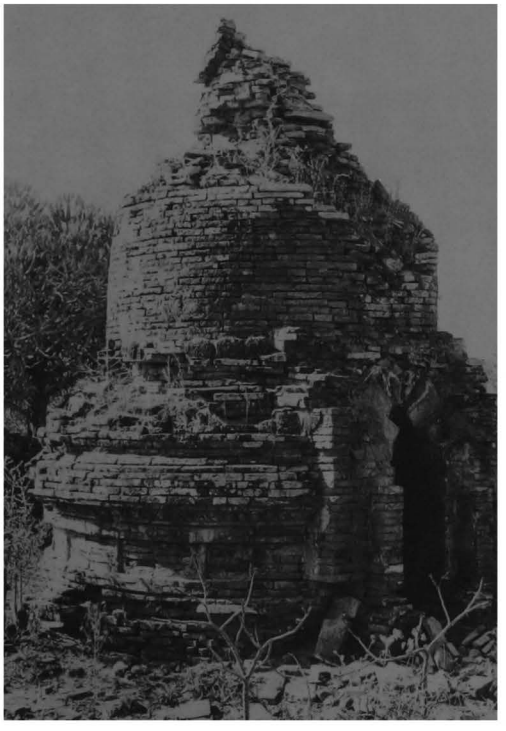
946 c - From north-east

5 present condition
- no maintenance.
- upper parts damaged.

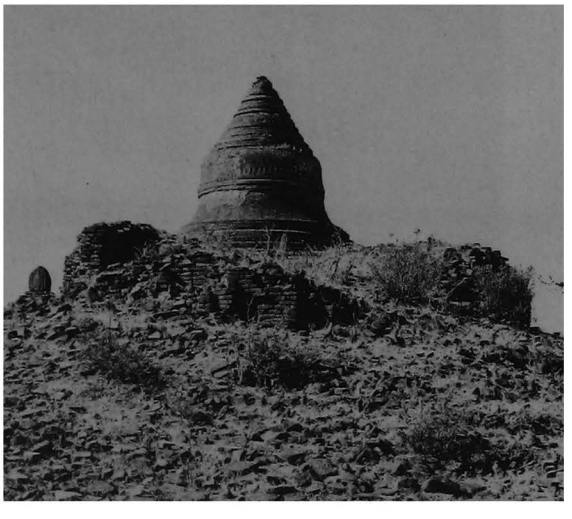
5 present condition
- ruined.
- vault collapsed.
- ground floor buried under debris.

948 b - From north-east, together with 947

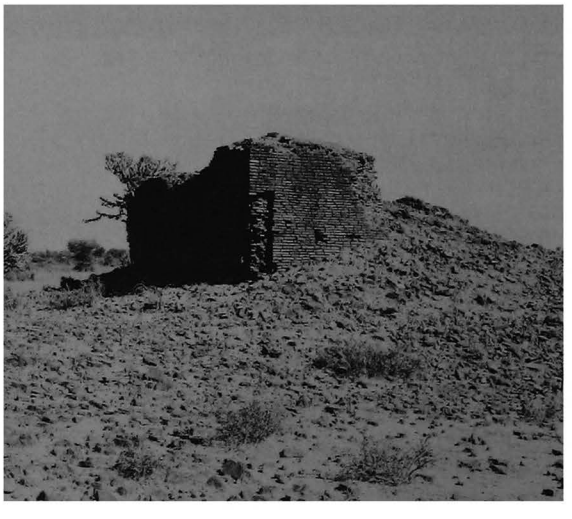
948 c - From south-west

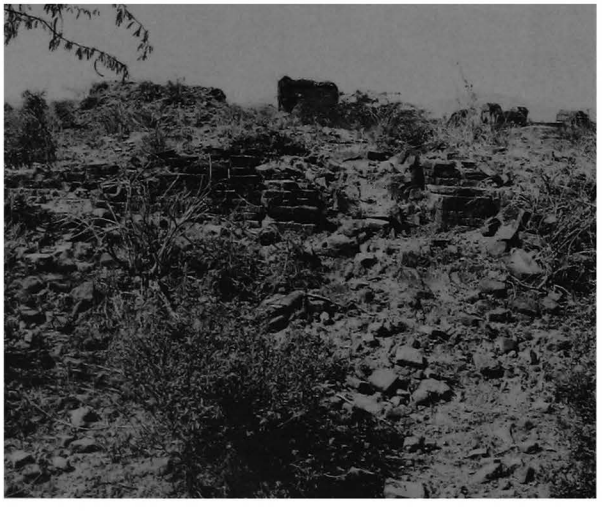
5 present condition
- ruined.
- only base of east wall remains.
- ground floor buried under debris.

950 b - East face

950 c - South-east corner, from south-east

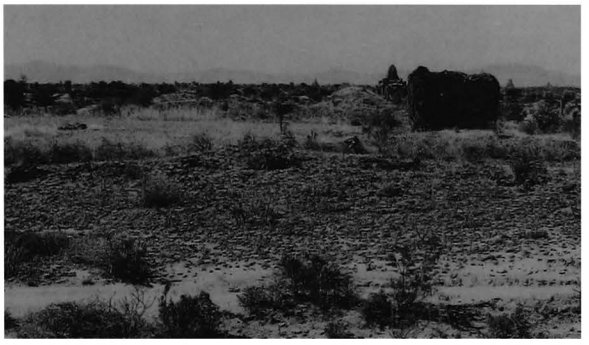
5 present condition
- ruined.
- walls and vault collapsed.
- ground floor buried under debris.

952 b - From east, together with 959

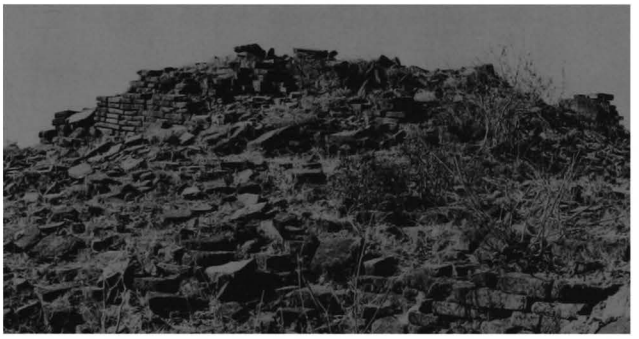
5 present condition
- ruined.
- walls and vaults collapsed.
- ground floor buried under debris, height: 2.30 m.

954 b - From north-east

954 c - North outer door, from south-east

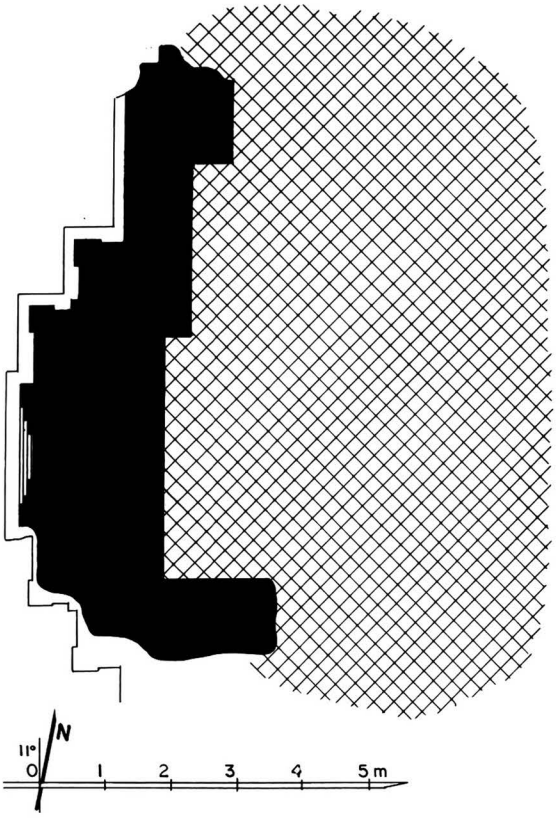
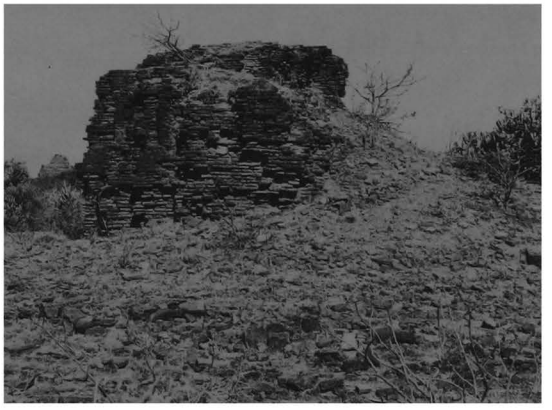
956 b - From north-east

956 c - From south-east

5 present condition
- ruined.
- vaults collapsed.
- only west face remains.
- ground floor buried under debris.

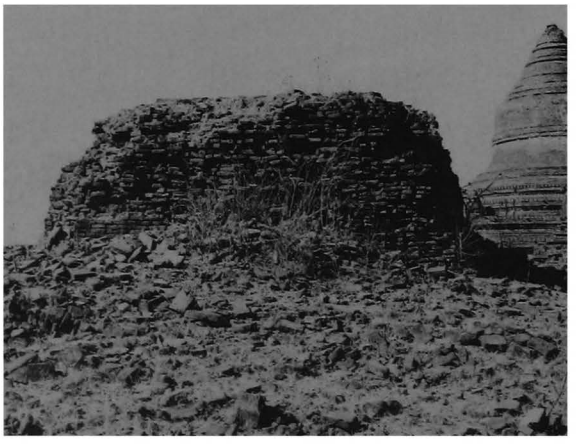
5 present condition
- ruined.
- vaults and outer wall collapsed.
- ground floor buried under debris.

957 b - East face, together with 947

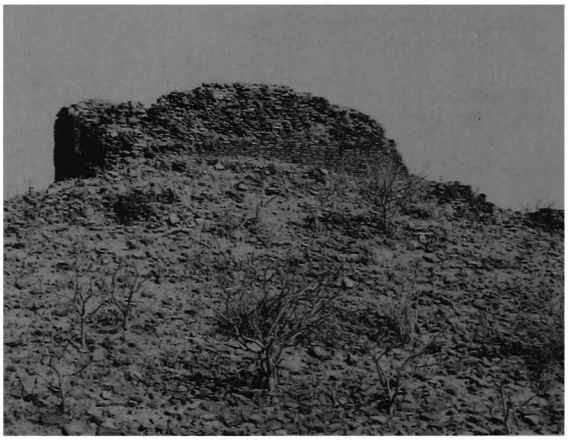
957 c - South face, from south-west

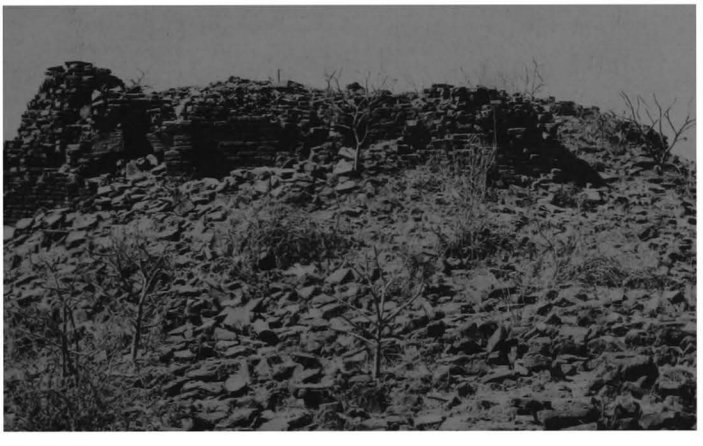
5 present condition
- ruined.
- walls and vault collapsed.
- ground floor buried under debris.

958 b - From east

958 c - From south

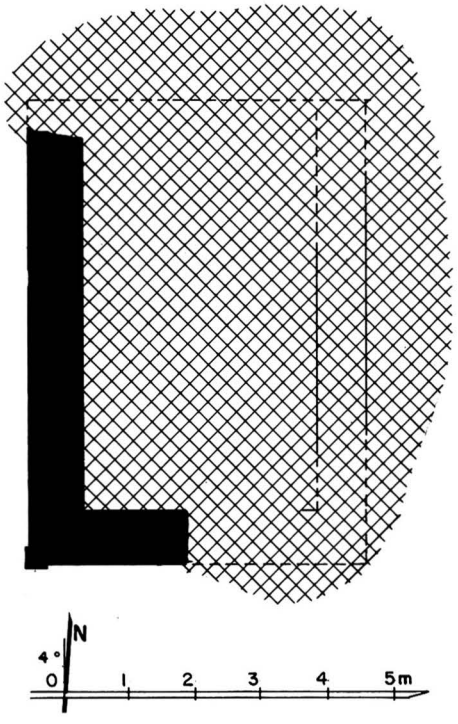
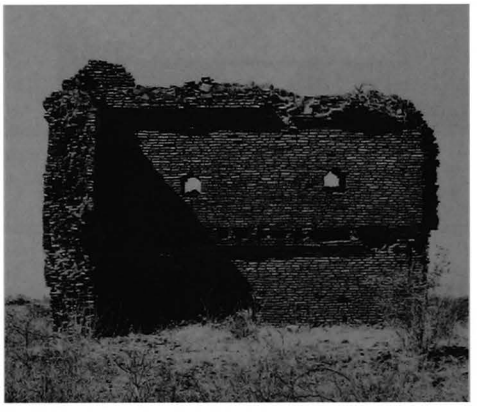
959 b - West face

959 c - From east

5 present condition
- ruined.
- only west wall remains.
- ground floor buried under debris.

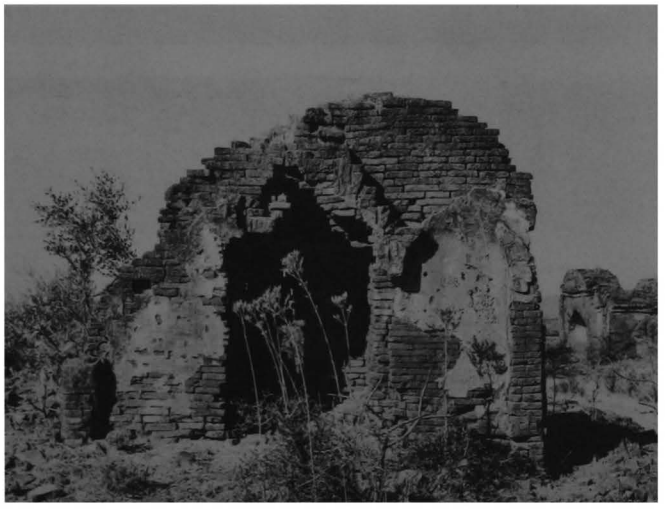
5 present condition
- ruined.
- no more trace of vault.
- only central part of east wall remains.

960 b - East face

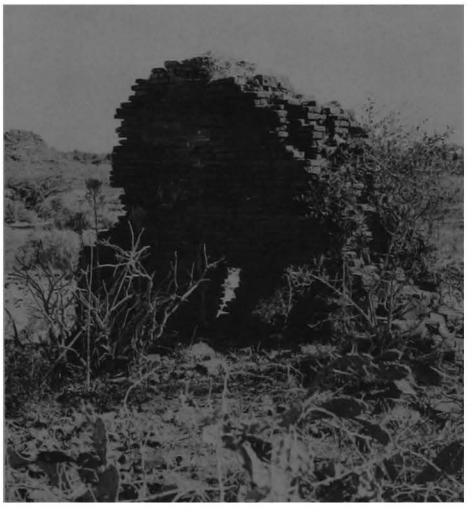
960 c - From south-west

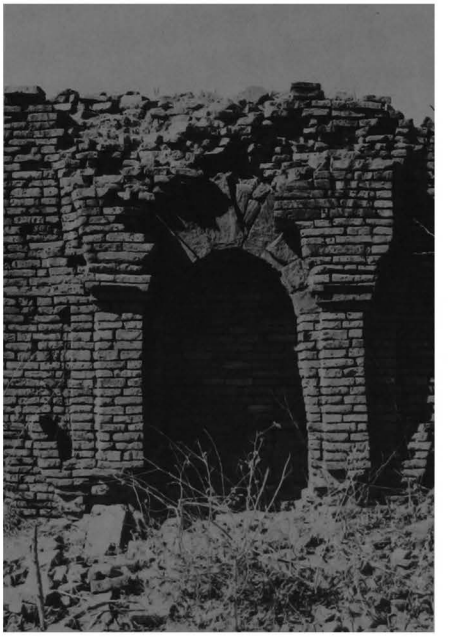
5 present condition
- ruined.
- no more trace of vaults.
- ground floor buried under debris.

962 b - From south-west

962 c - East face

962 d - East face, axial niche

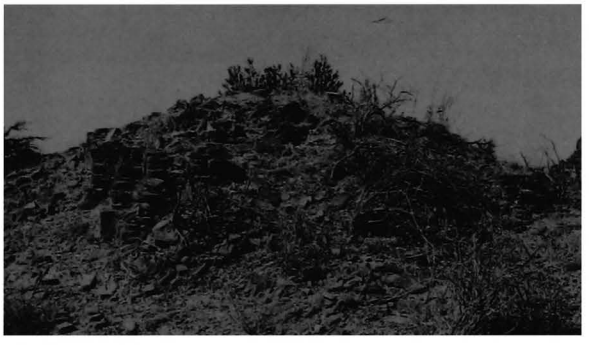
5 present condition
- ruined.
- vaults and upper parts collapsed.
- ground floor buried under debris, approx. height: 3.20 m.

963 b - From east

963 c - From south-west

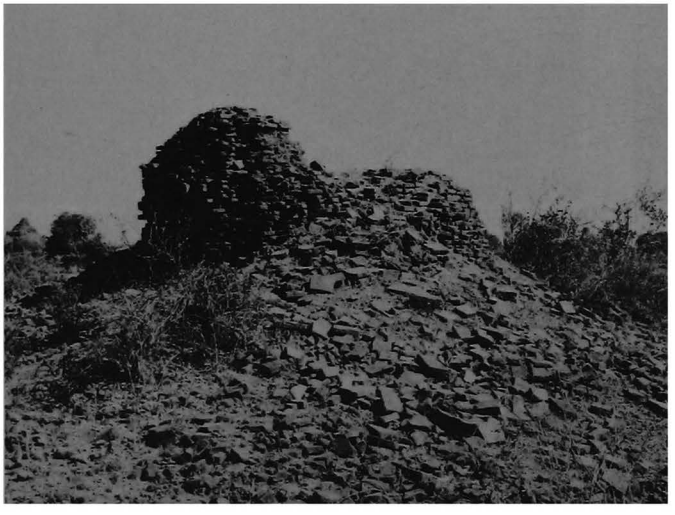
5 present condition
- ruined.
- base and terraces disintegrated.
- upper parts nearly destroyed.

965 b - From south-west

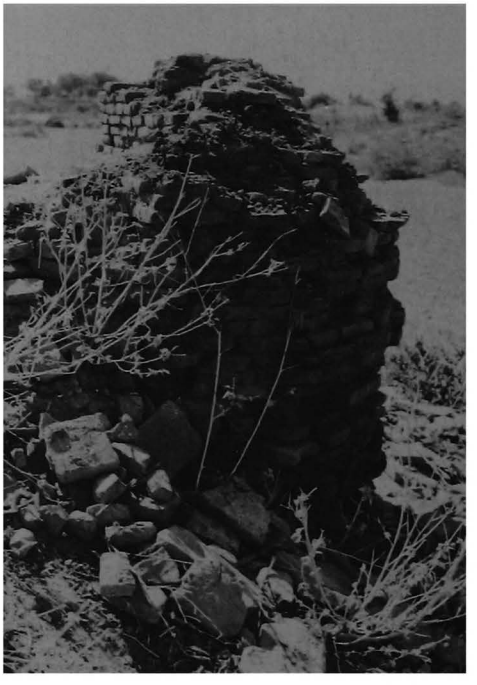
965 c - From north-east

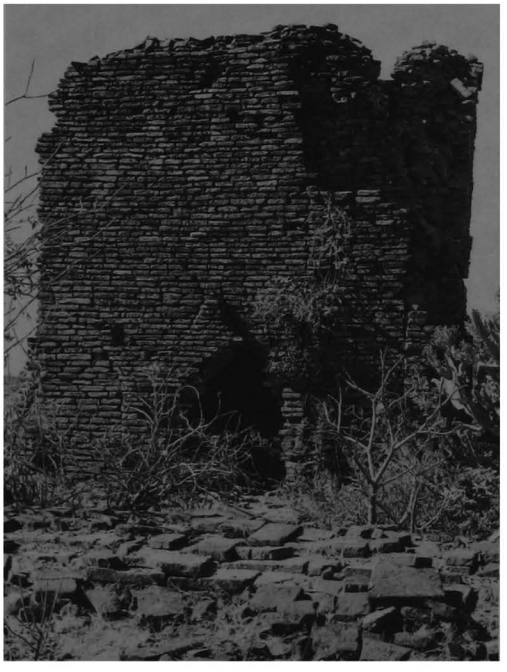
5 present condition
- half-ruined.
- no more trace of vaults.
- outer wall collapsed.
- ground floor buried under debris.

966 b - Central room, east face

966 c - Central room, from south

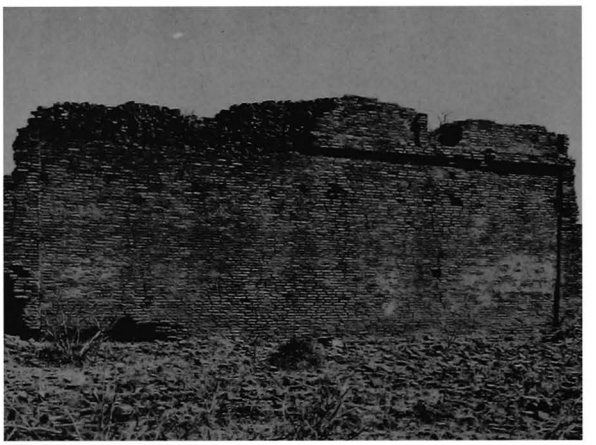
5 present condition
- ruined.
- no more trace of vaults.
- ground floor buried under debris.

967 d - West face
